IMPROVED MATERIALS AND MANUFACTURING
METHODS FOR GUN BARRELS. PART I

SWERR-TR-72-54

**IMPROVED MATERIALS AND MANUFACTURING
METHODS FOR GUN BARRELS
(PART I)**

August 1972

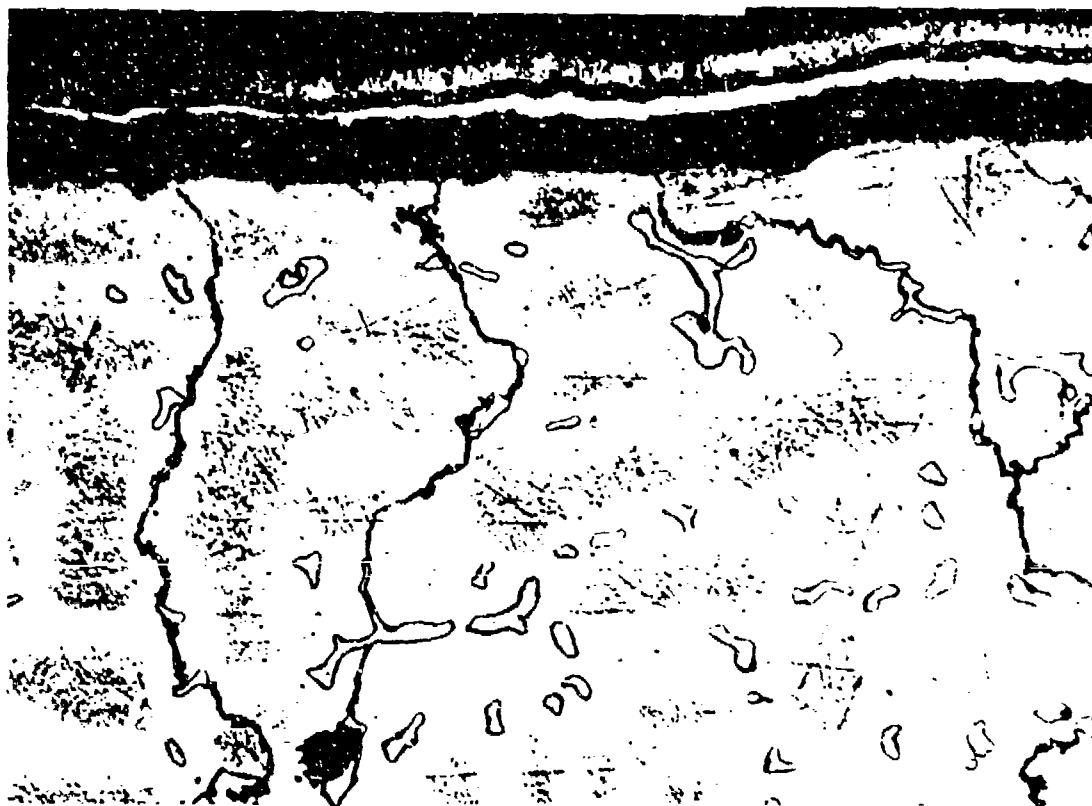
Figures 12 and 13 exhibit transverse microstructures along the bore of the Haynes Stellite 21 test insert after 5 firings in the vented bomb with IMR and WC846 propellants. The nickel plating did not adhere very well to the bore surfaces. The bore surfaces appear to be quite irregular, and chips of metal have been removed.

FIGURE 12 PHOTOMICROGRAPH REVEALING THE TRANSVERSE STRUCTURE
ALONG THE BORE SURFACE OF A HAYNES STELLITE 21 INSERT AFTER
5 VENTED BOMB FIRINGS WITH WC846 PROPELLANT.

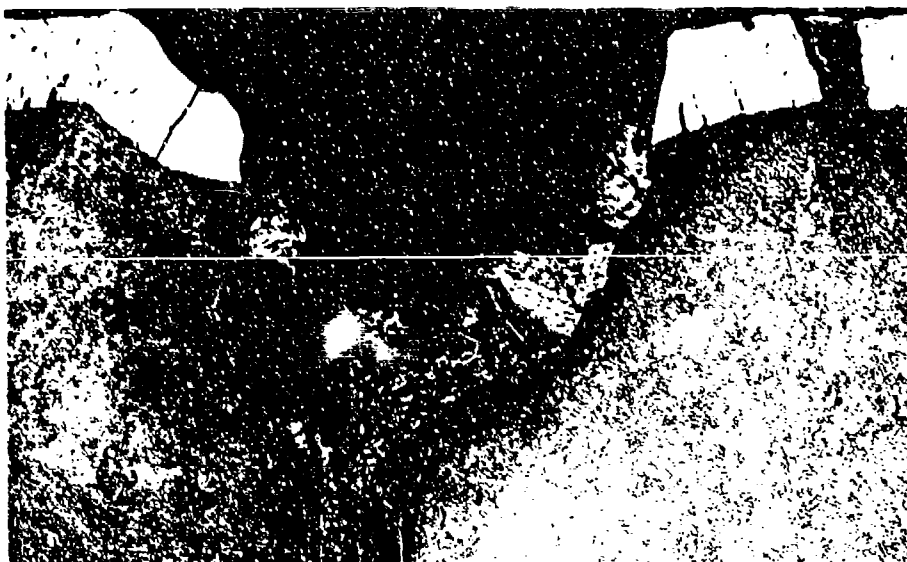
FIGURE 68 TRANSVERSE SECTION AT 1 1/2 INCHES FROM THE CHAMBER OF A CHROME-PLATED H11 STEEL GUN BARREL AFTER FIRING 24,466 ROUNDS AND BEING DECLARED UNSERVICEABLE.

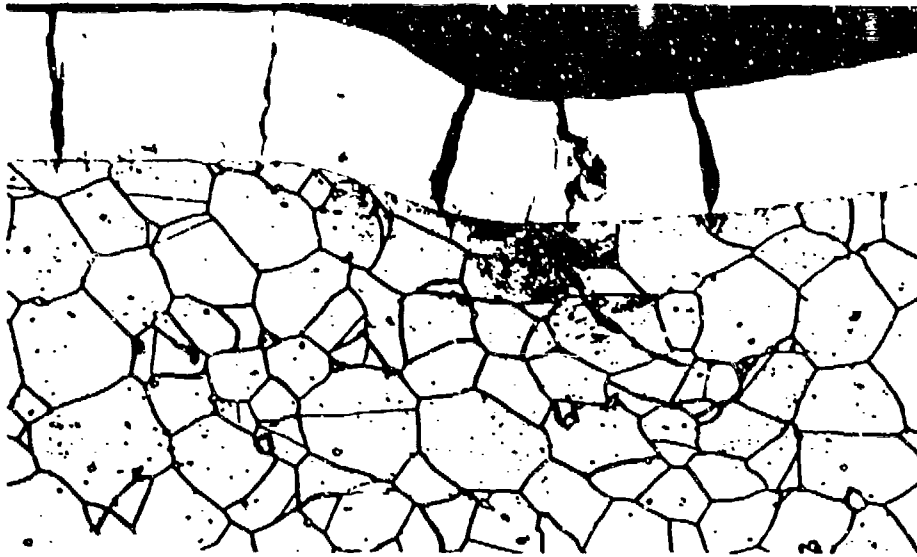
FIGURE 73 TRANSVERSE SECTION AT 1/2 INCH FROM THE CHAMBER OF A CHROME-PLATED CG-27 ALLOY BARREL AFTER FIRING 4,036 ROUNDS AND BEING DECLARED UNSERVICEABLE.

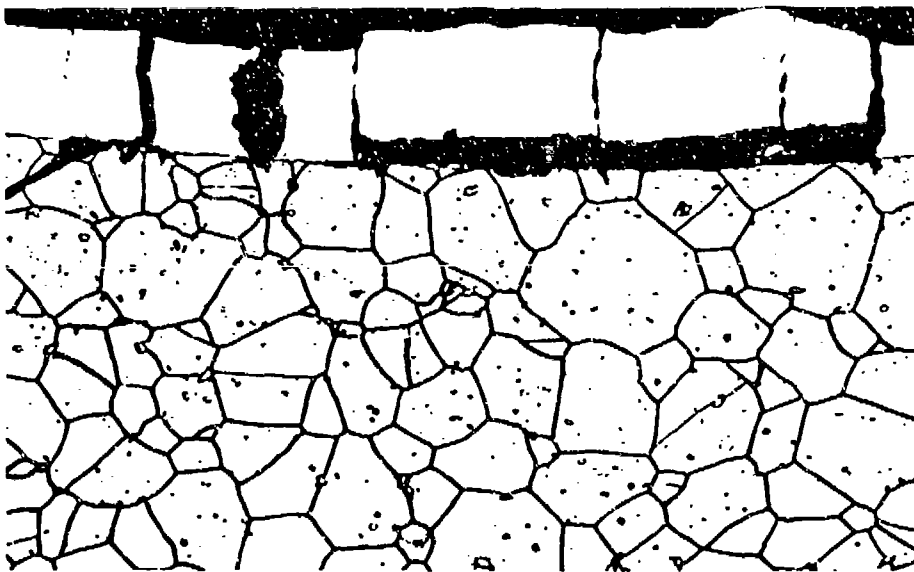
FIGURE 74 TRANSVERSE SECTION AT 1 1/2 INCHES FROM THE CHAMBER OF A CHROME-PLATED CG-27 ALLOY BARREL AFTER FIRING 4,036 ROUNDS AND BEING DECLARED UNSERVICEABLE.

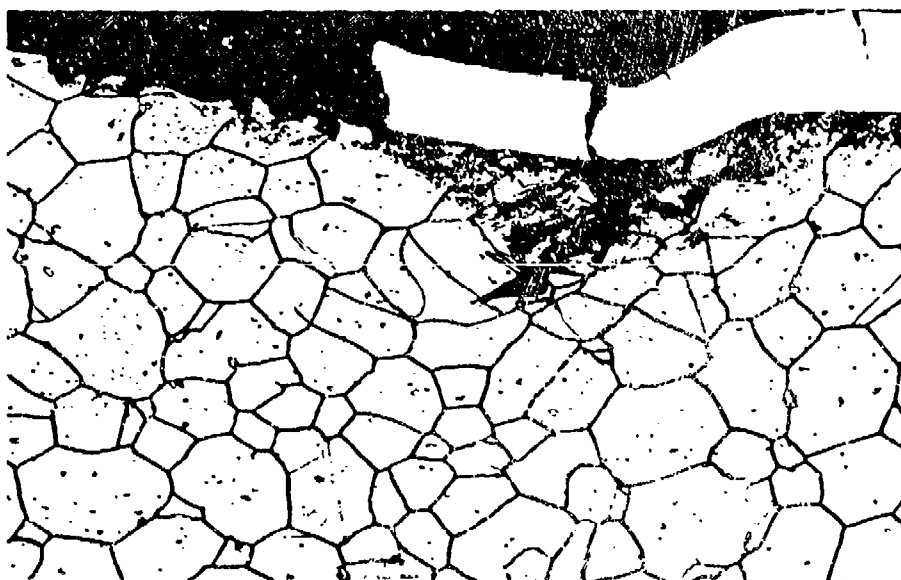
FIGURE 80 TRANSVERSE SECTION AT 1 1/2 INCHES FROM THE CHAMBER OF A CHROME-PLATED CG-27 ALLOY BARREL AFTER FIRING 7,324 ROUNDS AND BEING DECLARED UNSERVICEABLE.
